# Garde Arts Center

## New London, CT

### THE GARDE ARTS CENTER

## OUR UNIQUE "RIGHT OF PASSAGE"

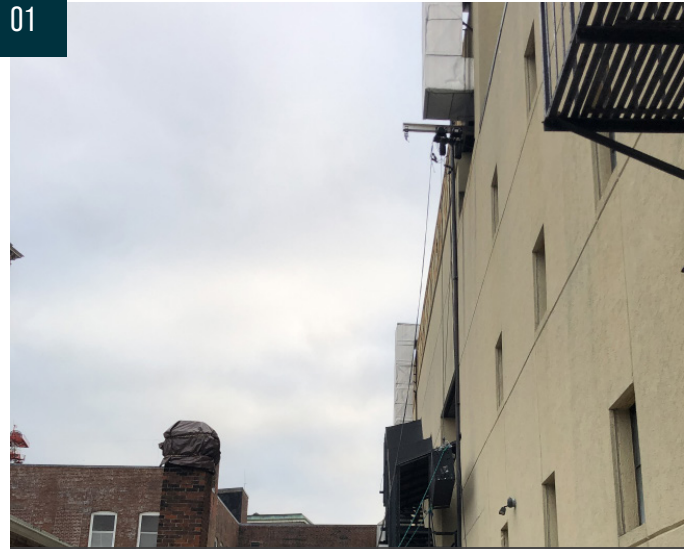
01

SCENE 1: Our first challenge was raising the hoist up to the level of the shaft cover high on the outside of the building – including a temporary installation of rigging to cantilever the large hoist from the building's internal steel structure to get it in safely!

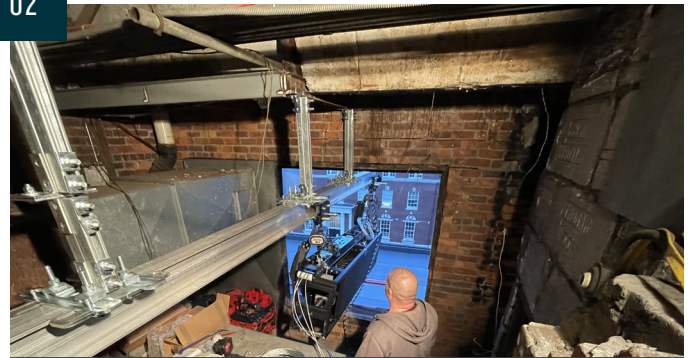
02

SCENE 2: Once we had the hoist up to the shaft opening, we were able to move it along the inside of the shaft using a custom temporary rail assembly and chain motors we rigged up that allowed us to ensure it could be moved safely and without coming into contact with other equipment.

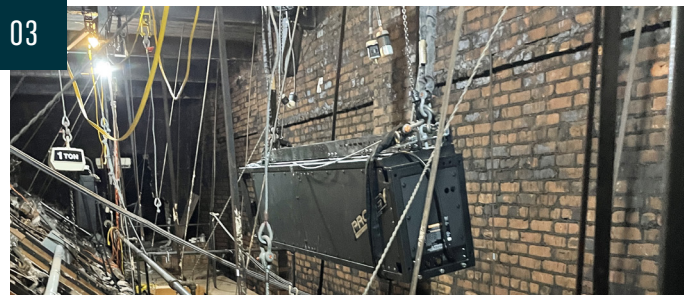
03

SCENE 3: At the midpoint of its journey, the hoist needed to go left from here and into an even smaller access hole above the ceiling. The space shown here is above the proscenium and had ample working room, but the tight space above the ceiling had access of only 44" and the space above the plaster dome where the hoist lived was 25 1/2" giving us the smallest clearance margin. With the hoist in position above its destination, we could close up the outside entry point, disassemble the rail, and prepare to lower it into position.

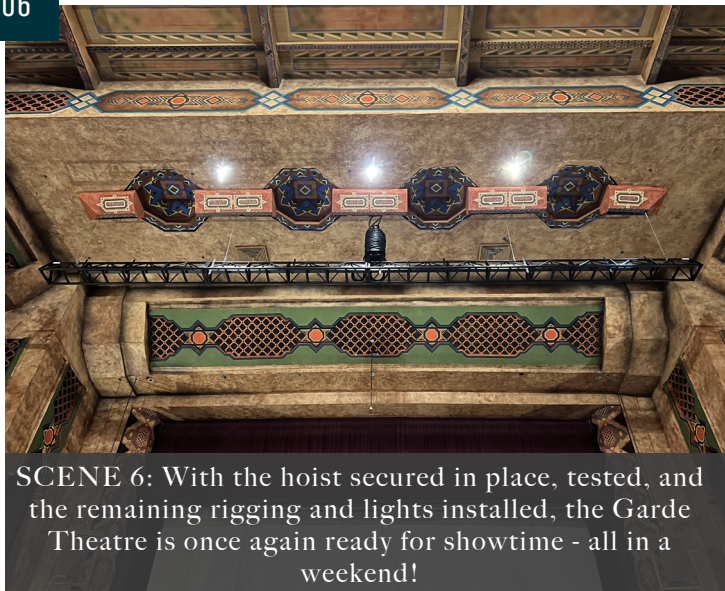
06

SCENE 6: With the hoist secured in place, tested, and the remaining rigging and lights installed, the Garde Theatre is once again ready for showtime - all in a weekend!
